TEST REPORT

REPORT NUMBER: 3136050SAT-001
ORIGINAL ISSUE DATE: November 15, 2007
REVISED DATE: N/A

PRODUCT EVALUATED: 2 x 4 and plywood walls and ceiling, 16 inch o.c. with generic wall-cavity spray insulation.
EVALUATION PROPERTY: Heat Release, Flame Spread

Report of testing 2 x 4 and plywood walls and ceiling, 16 inch o.c. with generic wall-cavity spray insulation. for compliance with the applicable requirements of the following criteria: NFPA 286 and IBC 803.2.1.

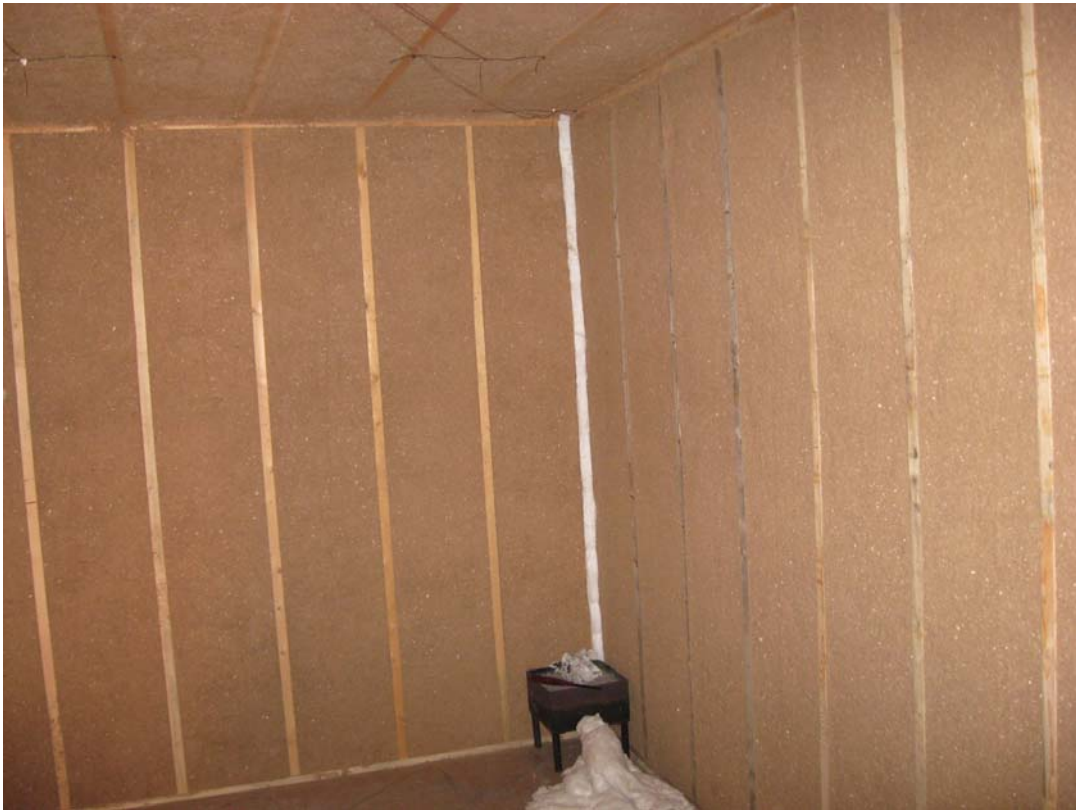
Pre-test photo of right corner

In the right corner where the test burner would eventually be placed, the corner was constructed such that there was a single stud running from the floor to the ceiling. Prior to the test, the surface of this stud was covered with a strip of ceramic blanket the exact width of the stud. This was affixed with staples.

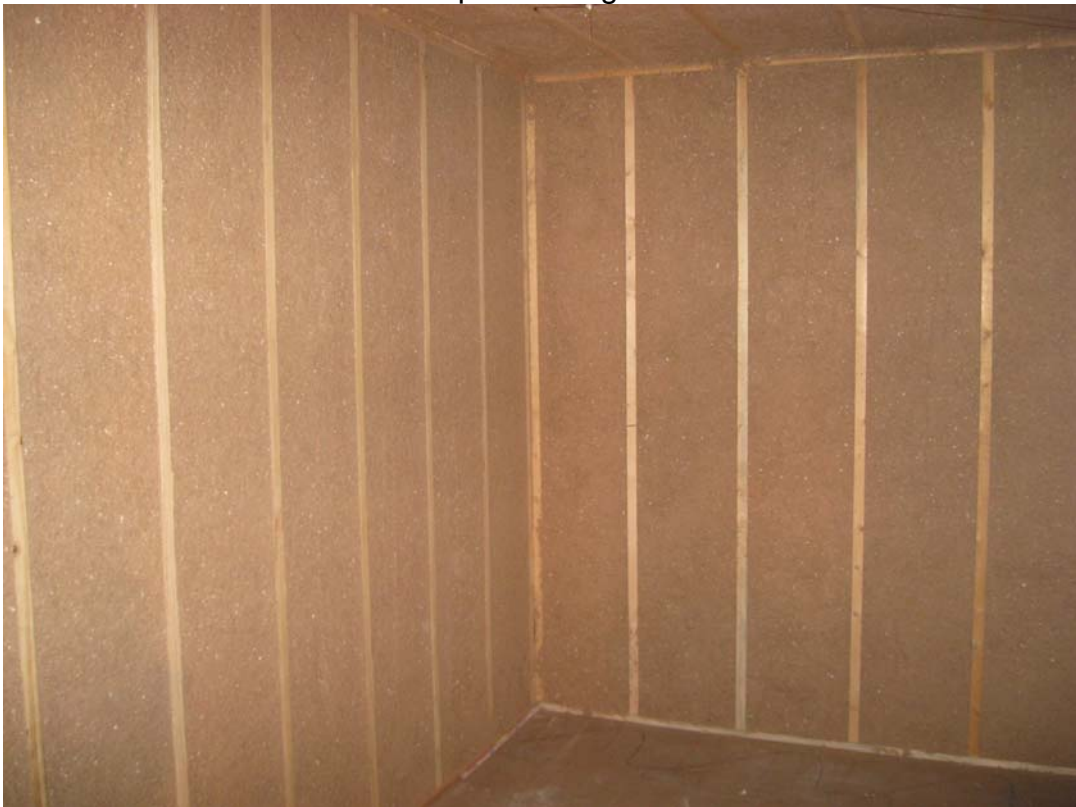
Pre-test photo of left corner

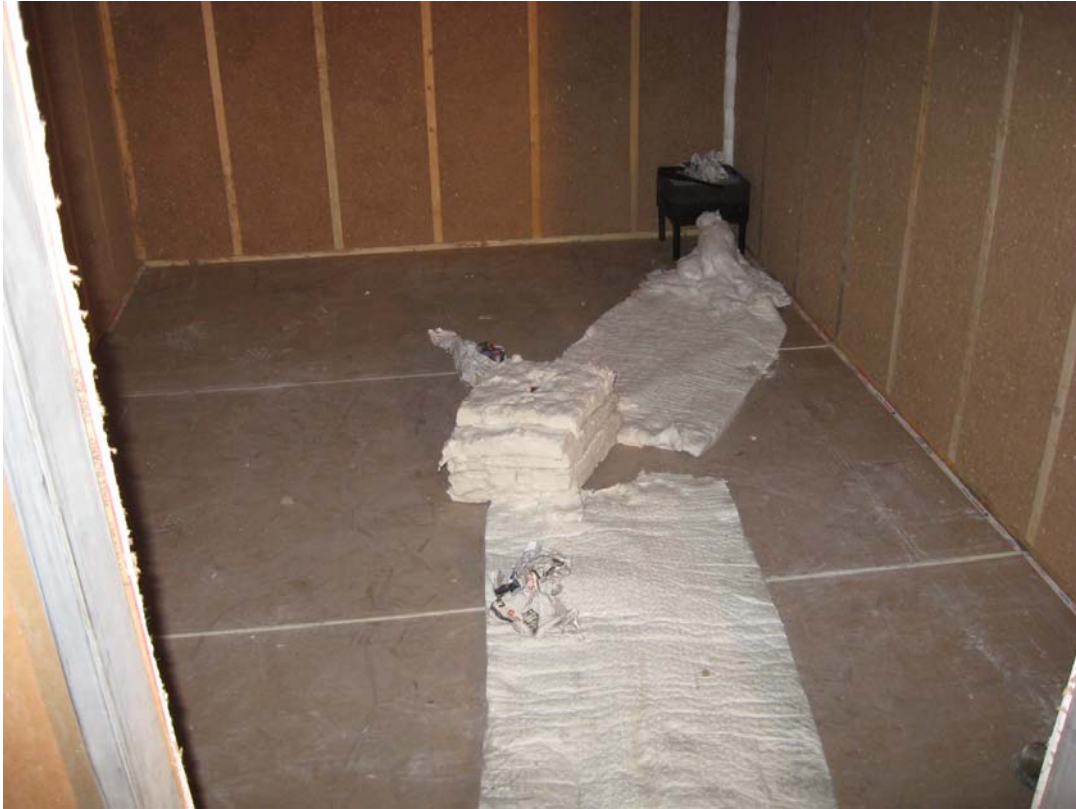
Pre-test photo of paper targets.

The paper targets did not spontaneously ignite due to flash-over conditions.

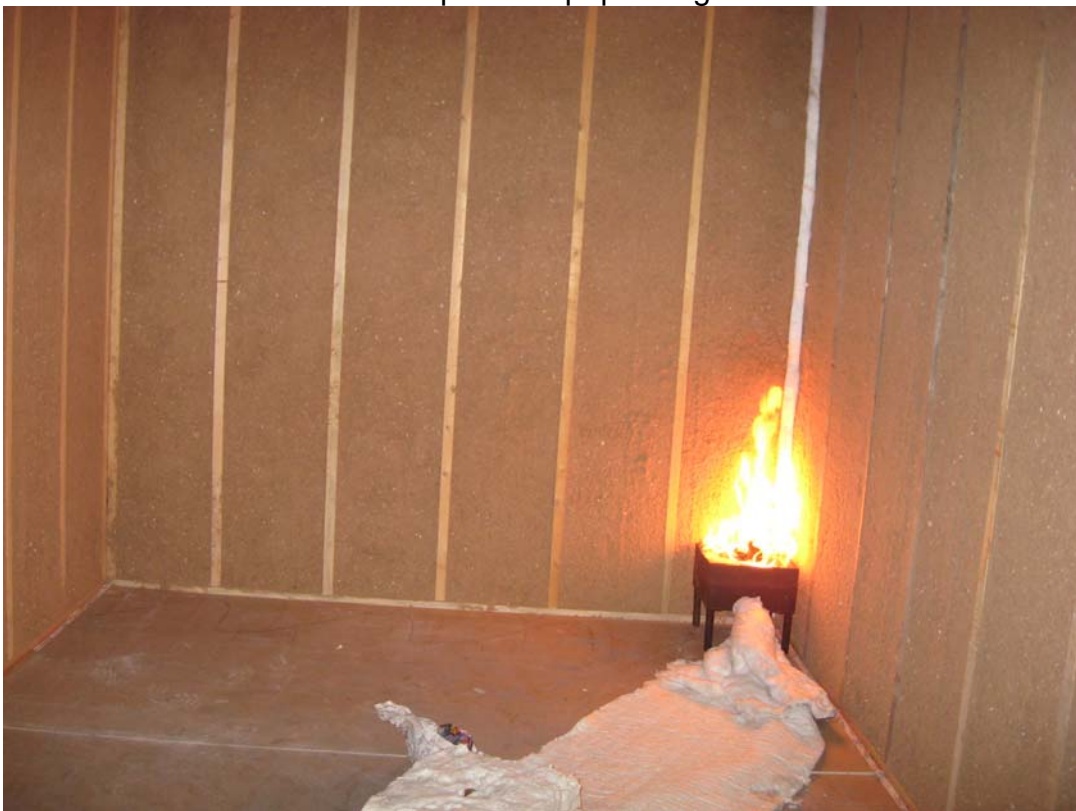
Start of test

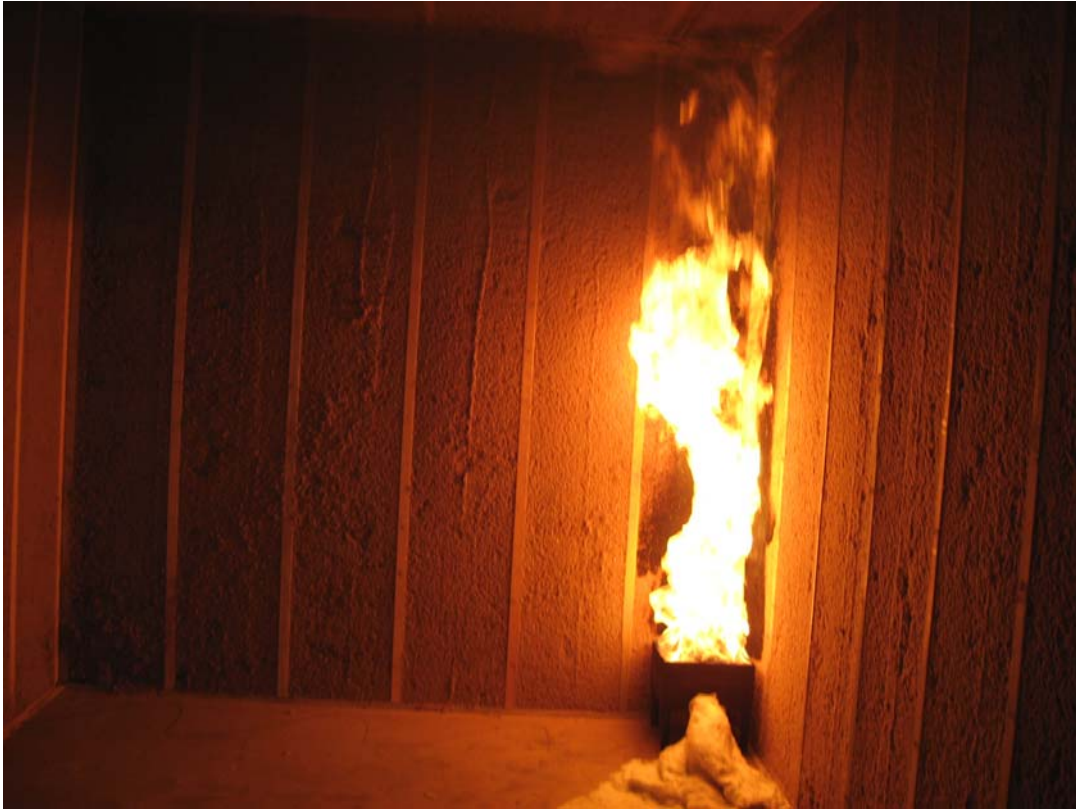
160 kW flame.

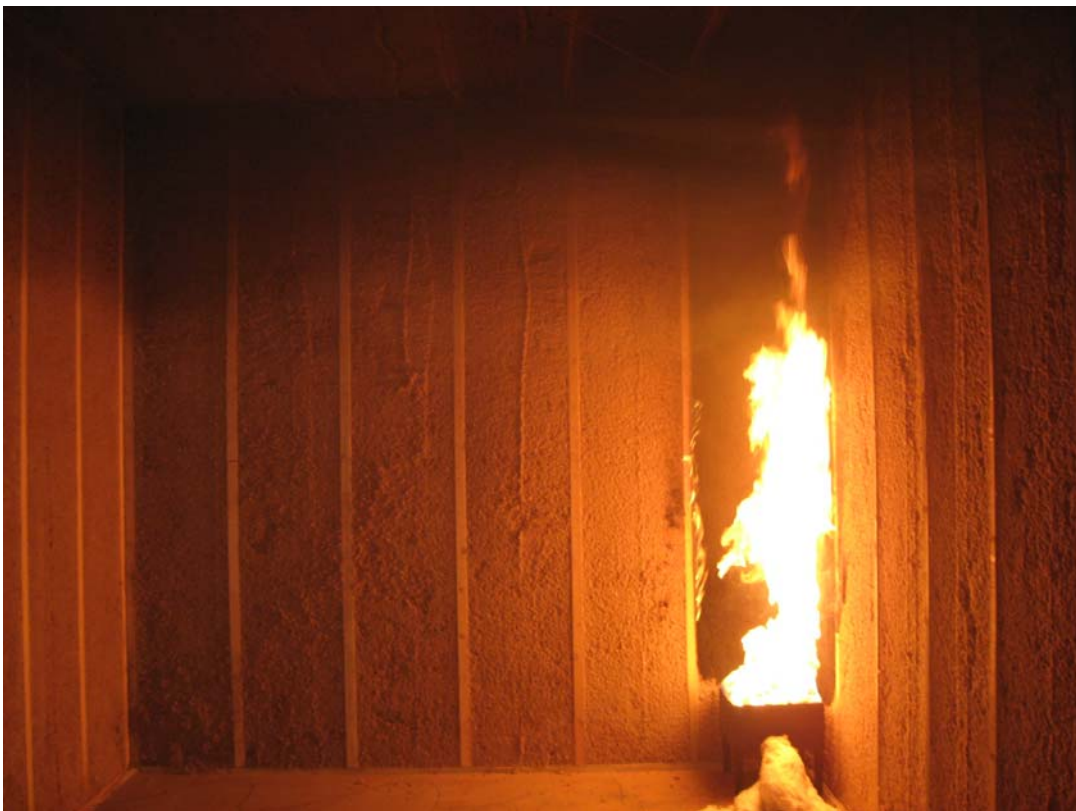
160 kW flame and ignition of studs.

9:57	The studs on the back wall and right side wall showed sustained ignition.
15:00	Standard specified end of test. No signs of flashover or flames reaching the extremities of any wall. The gas ignition source was allowed to continue for an additional five minutes.

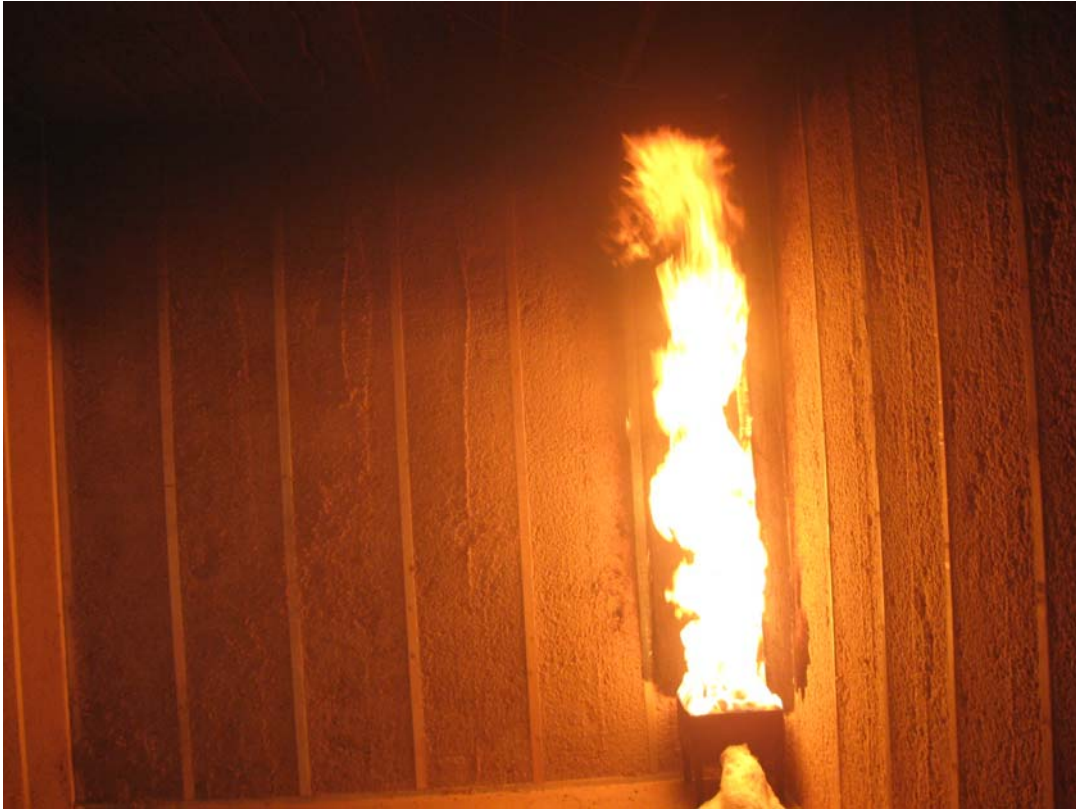
160kW at 20 minutes.

17:55	Glowing particulate fell from the ceiling and extinguished upon hitting the floor of the test chamber.
18:30	A cavity approximately 3 inches wide was visible in the top right corner of the ceiling where the walls and ceiling met. Some smoke began to vent to the outside through this opening.

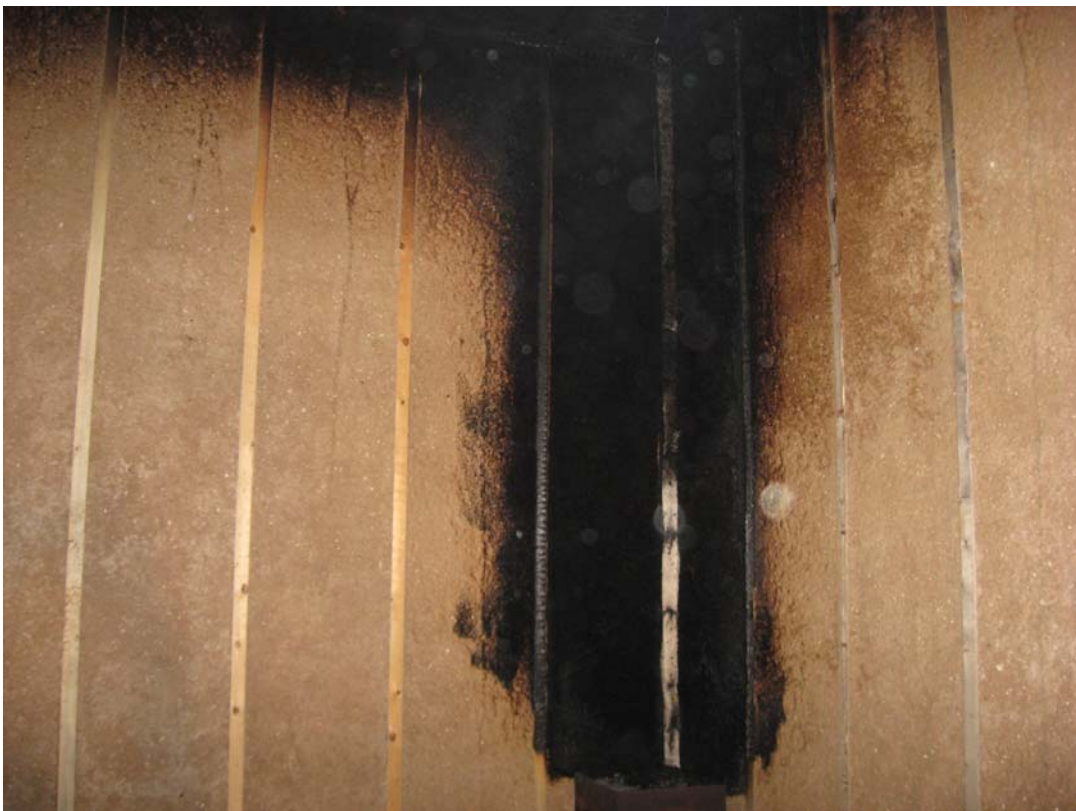
Post-test right corner.

Smoke and charring of the insulation and studs were limited to the first two stud cavities. No insulation had fallen from the stud or joist cavities.

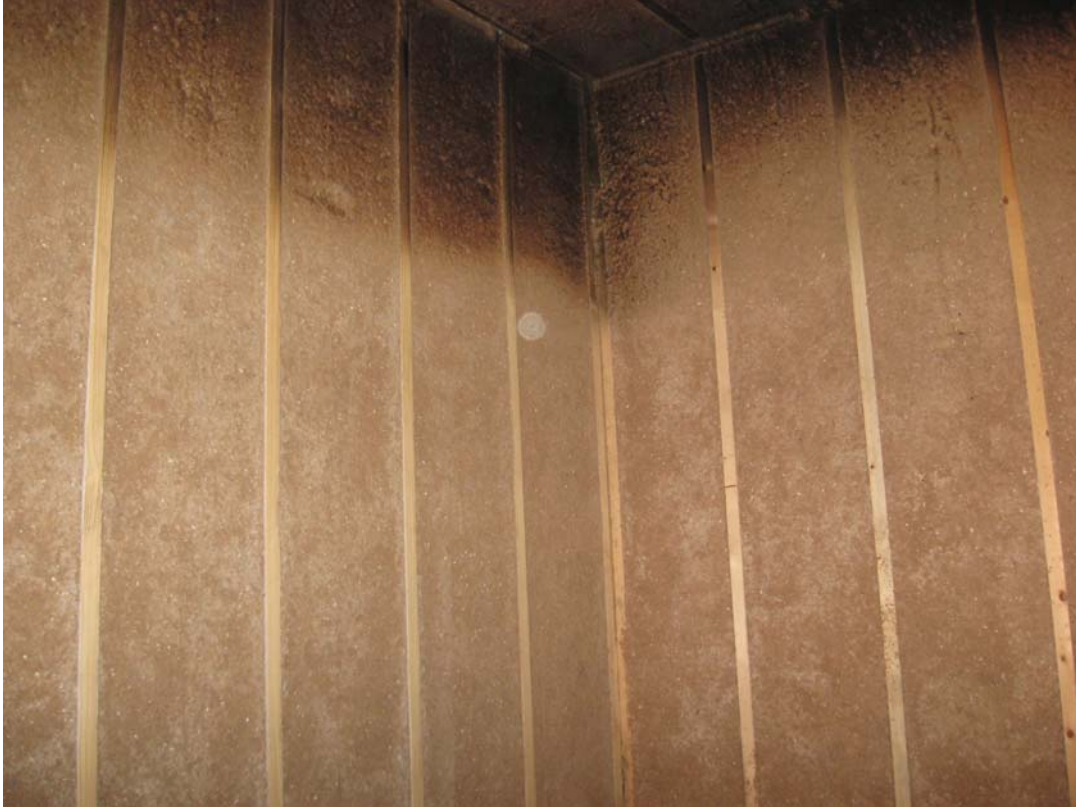
Post-test left corner.
