REPORT NUMBER: 3136050SAT-002
ORIGINAL ISSUE DATE: November 15, 2007
REVISED DATE: N/A

PRODUCT EVALUATED: 2 x 4 and plywood walls and ceiling EVALUATION PROPERTY: Heat Release, Flame Spread

Report of testing 2 x 4 and plywood walls and ceiling. for compliance with the applicable requirements of the following criteria: NFPA 286 and IBC 803.2.1.

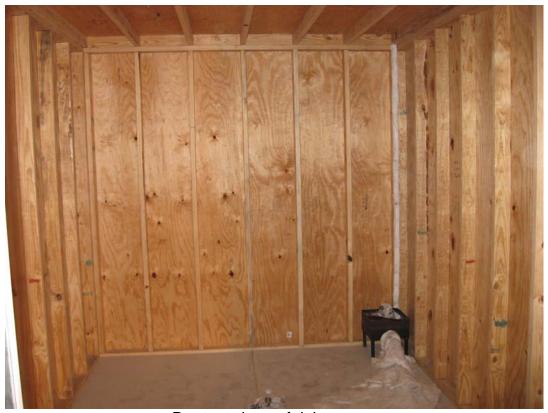
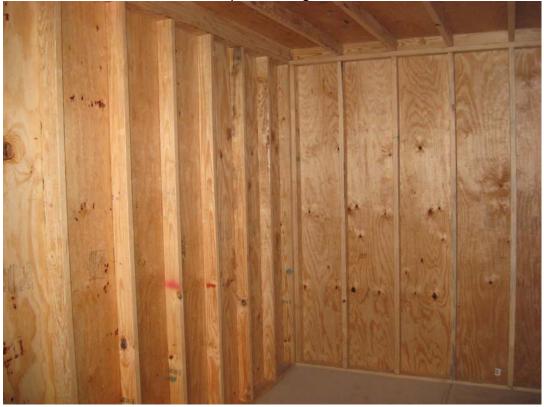
Pre-test photo of left corner

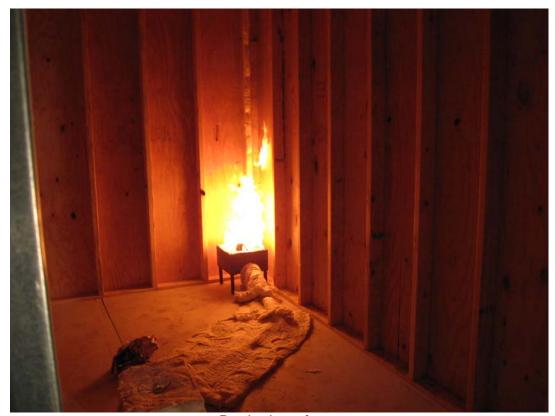
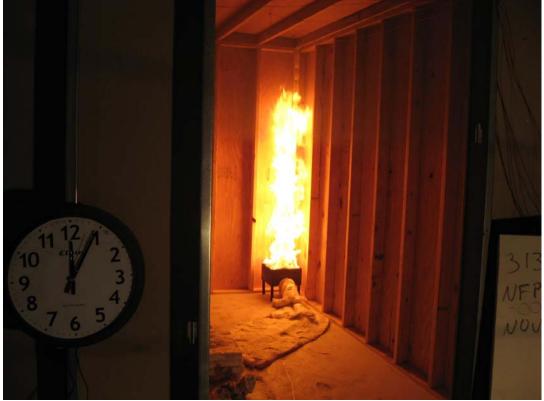
160 kW flame.

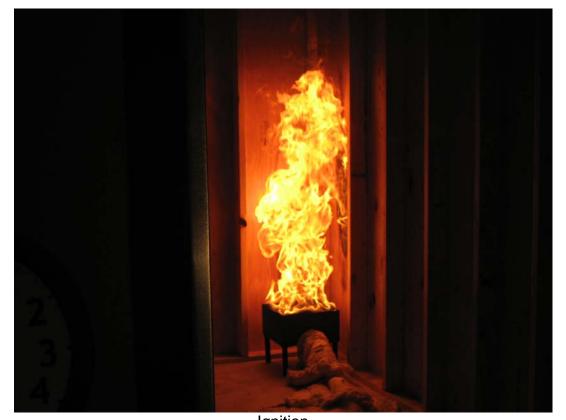
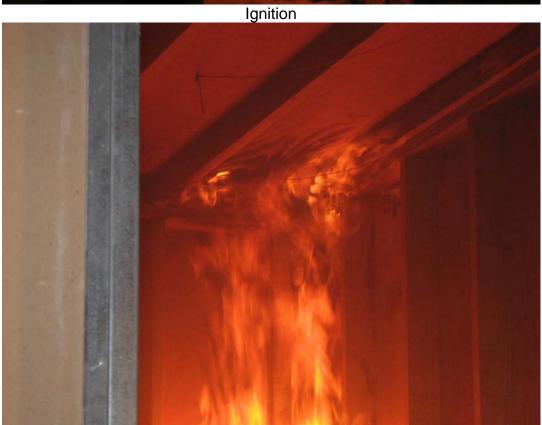
Ceiling ignition.

TIME		
(min:sec)	<u>OBSERVATION</u>	
0:00	Ignition of burner. Heat output set to 40 kW.	
2:30	No change to the system	
5:00	Burner output increased to 160 kW.	
5:34	Smoke output began to increase	
5:58	The back corner stud ignited.	
6:14	The ceiling ignited.	
6:45	The smoke formed a layer in the top of the room extending to ~3 ½ feet from	
	the floor.	
7:18	Flames began to exit the doorway of the room.	
7:20	Test terminated.

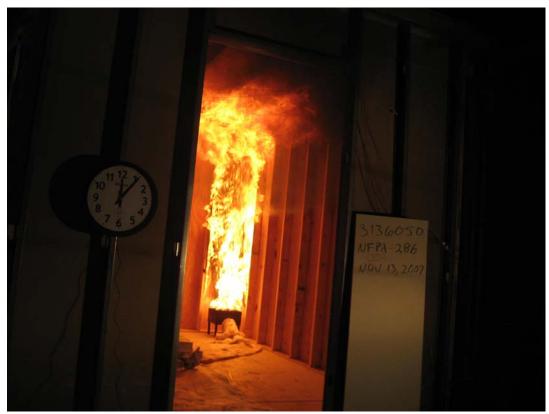
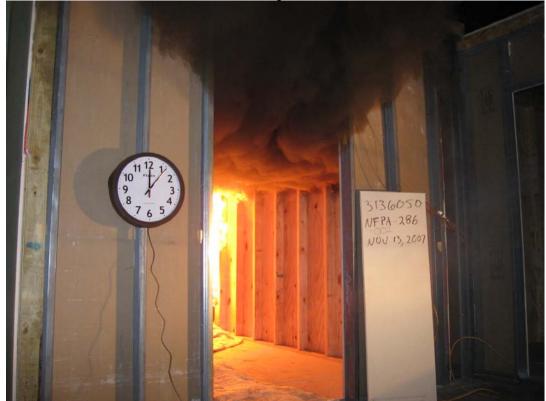
Smoke ceiling.

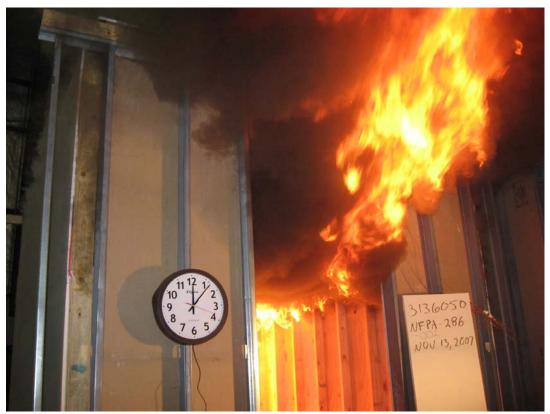
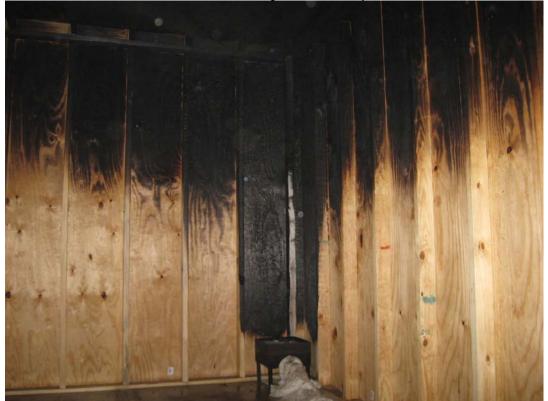
Post-test.

The two stud cavities in the corner with the burner were heavily charred and discolored from the middle of the wall up to the ceiling. The ceiling joists and plywood was likewise heavily charred and discolored.
