TEST REPORT

REPORT NUMBER: 3136050SAT-003
ORIGINAL ISSUE DATE: November 16, 2007
REVISED DATE: N/A

PRODUCT EVALUATED:
2x4 and plywood walls and ceiling with friction fit R-13 insulation
EVALUATION PROPERTY: Heat Release, Flame Spread

Report of testing 2 x 4 and plywood walls and ceiling with friction fit R-13 insulation. for compliance with the applicable requirements of the following criteria: NFPA 286 and IBC 803.2.1.

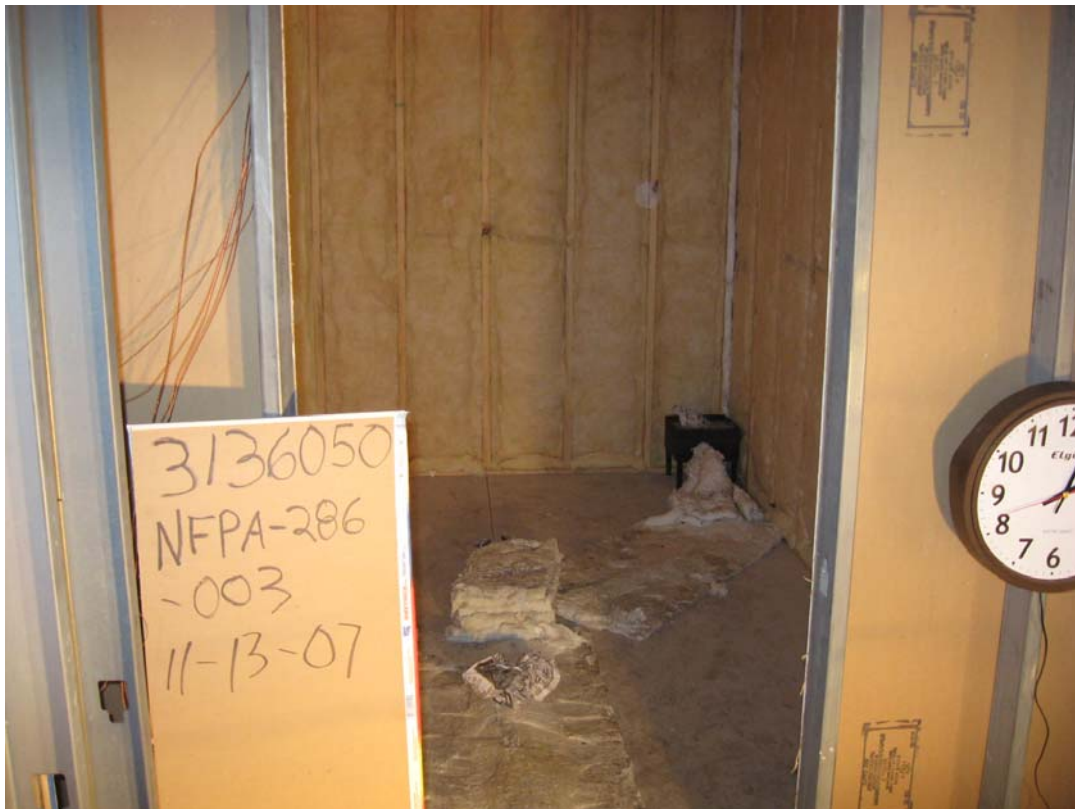
Pre-test photo of right corner

In the right corner where the test burner would eventually be placed, the corner was constructed such that there was a single stud running from the floor to the ceiling. Prior to the test, the surface of this stud was covered with a strip of ceramic blanket the exact width of the stud. This was affixed to the stud with staples.

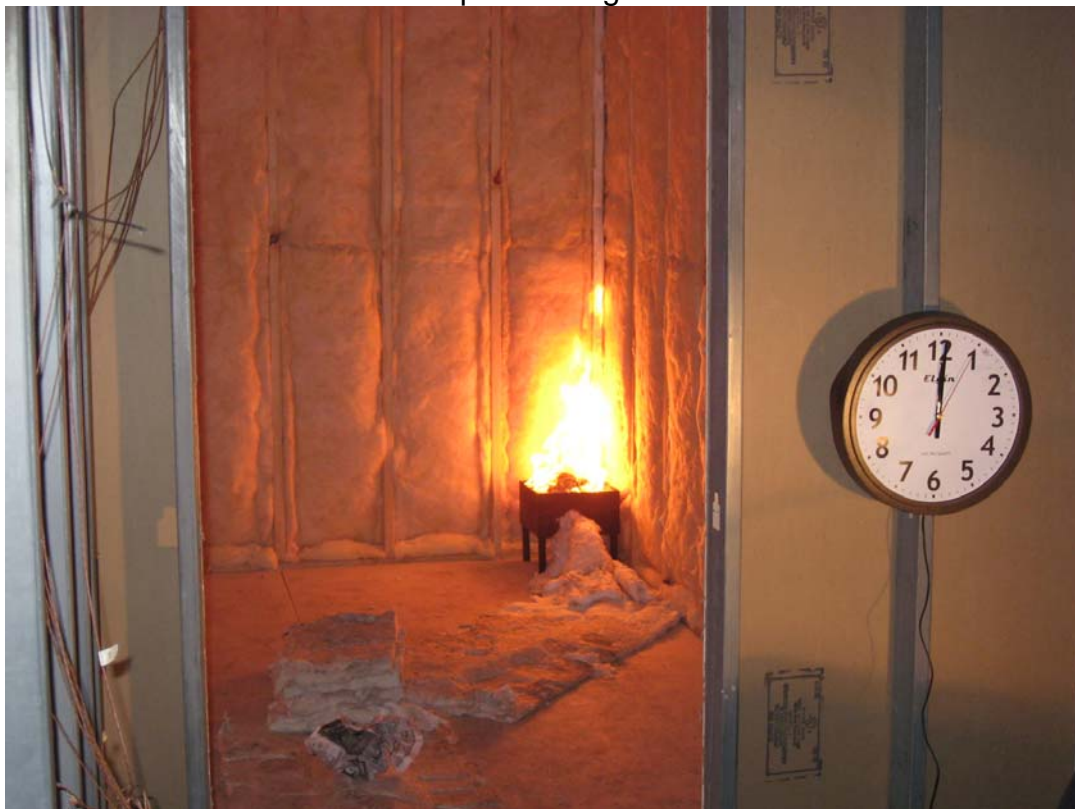
Beginning of test

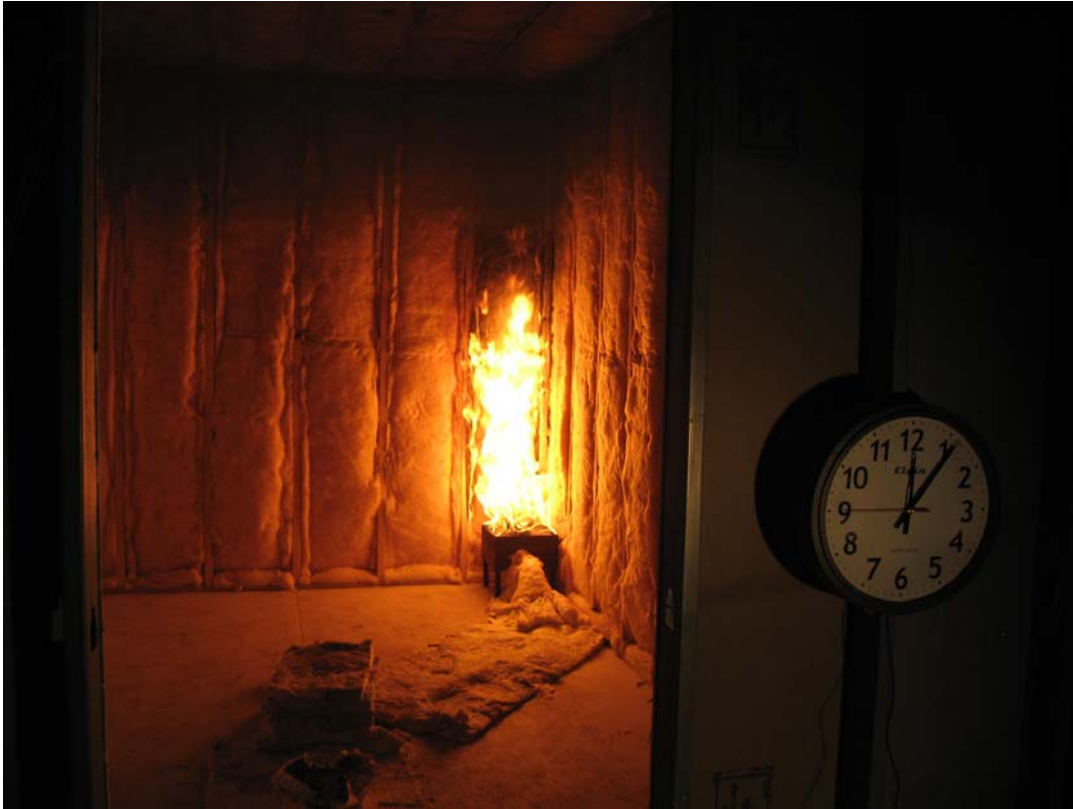
Ignition

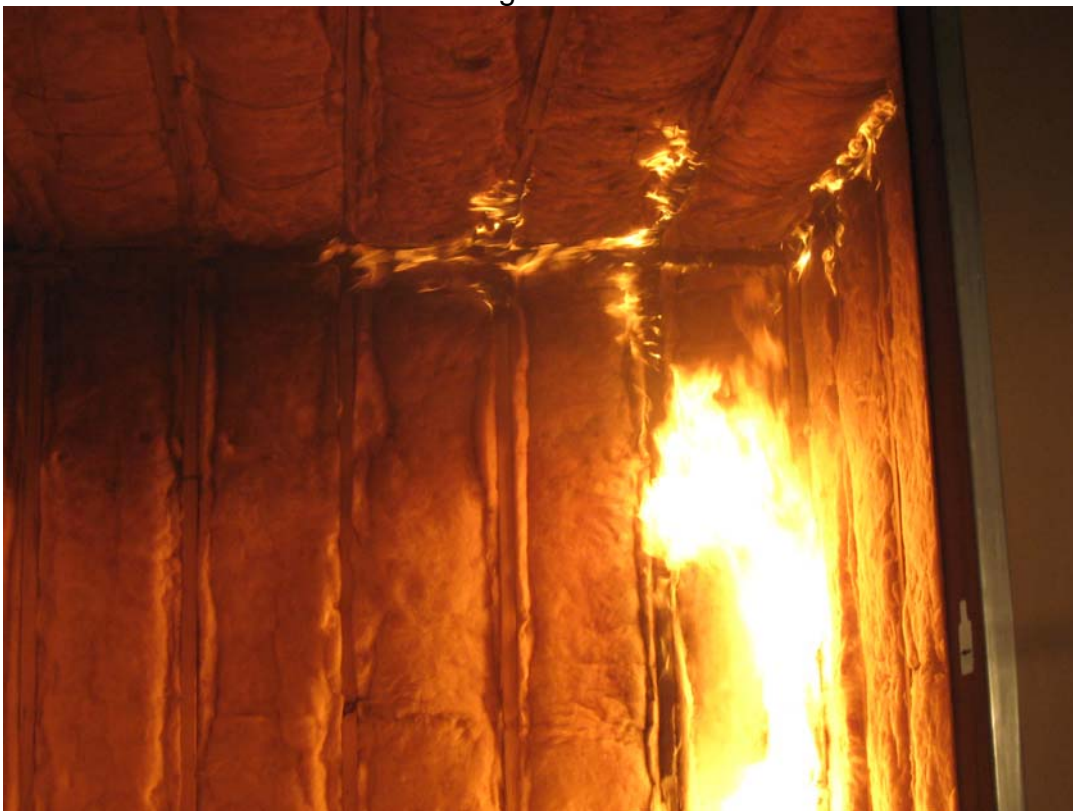
Ceiling ignition.

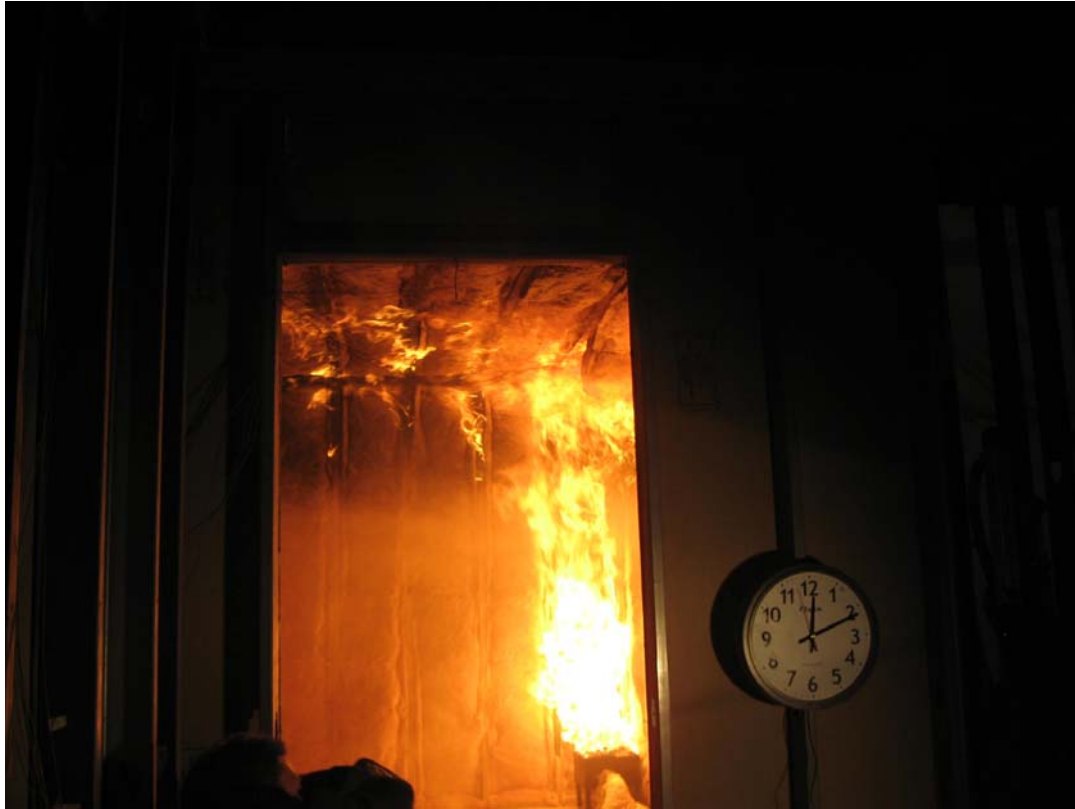
Increasing flames.

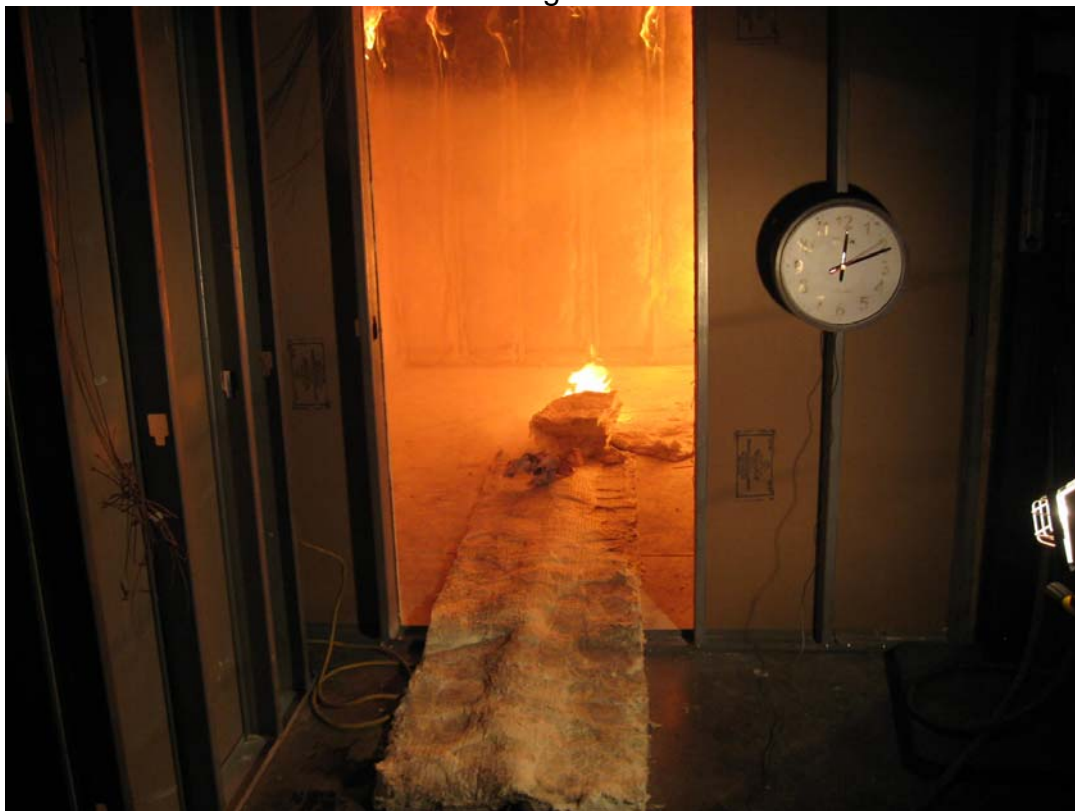
Ignition of first paper target.

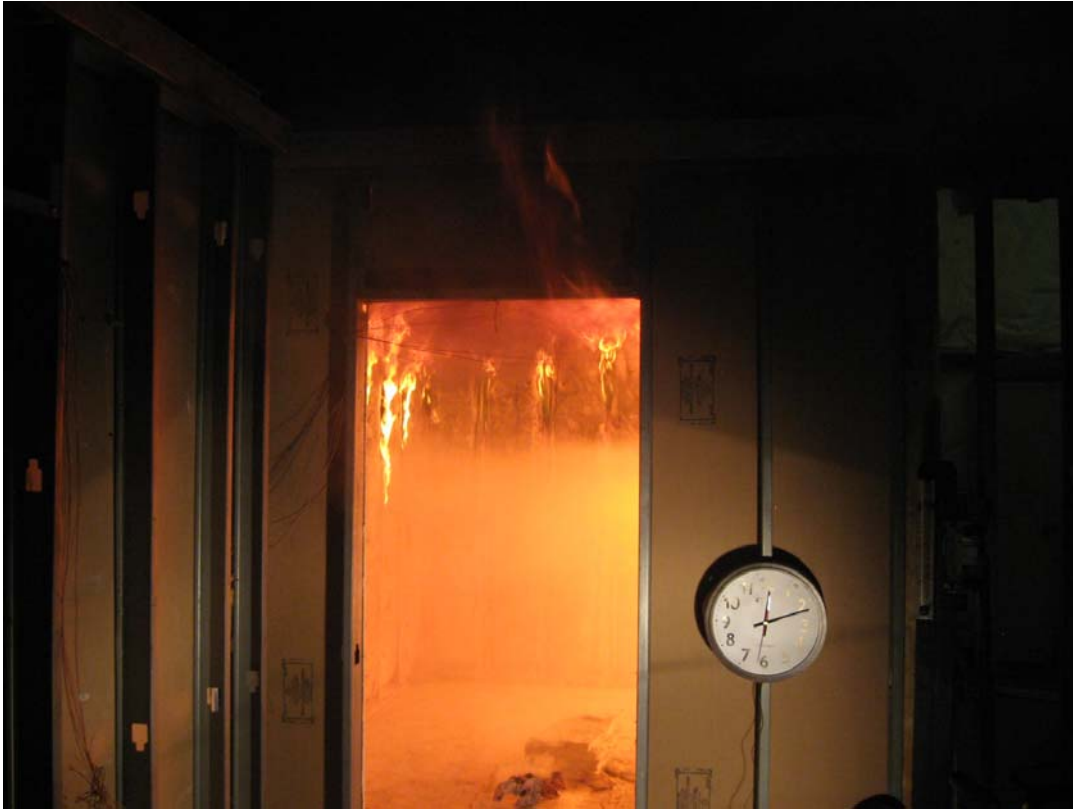
Flames exiting the doorway.
